Specialist Foundation Engineering in Europe

Analysis of accident occurrences from 1998 to 2008

Dipl.-Ing. Walter Ensinger, Munich

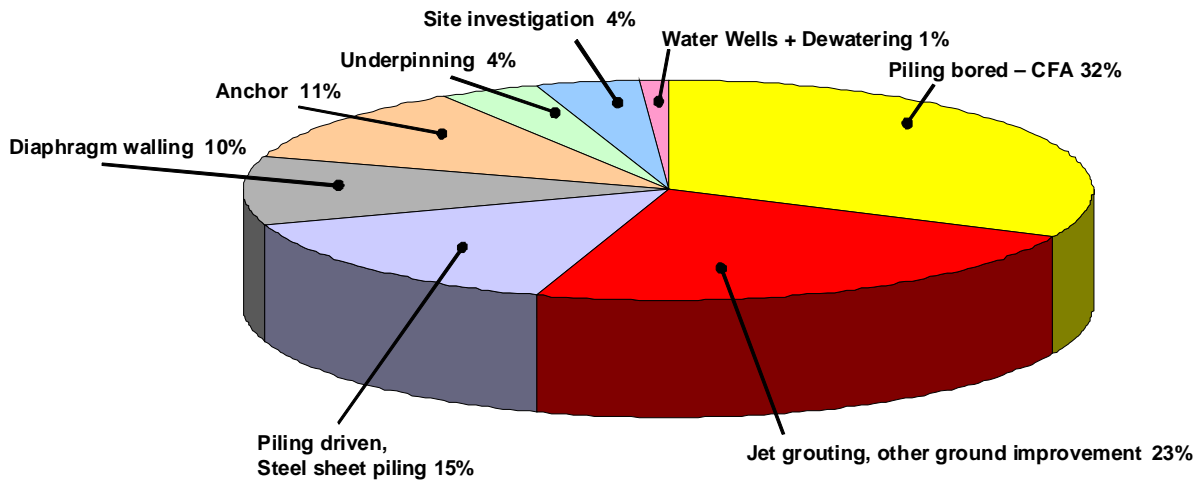
Fig. 2: Work processes (Share of the reported accidents)

The accident reports show that member companies of the EEFC are active in all sectors of specialist foundation engineering. The data collection and evaluation is therefore significant for the entire branch.

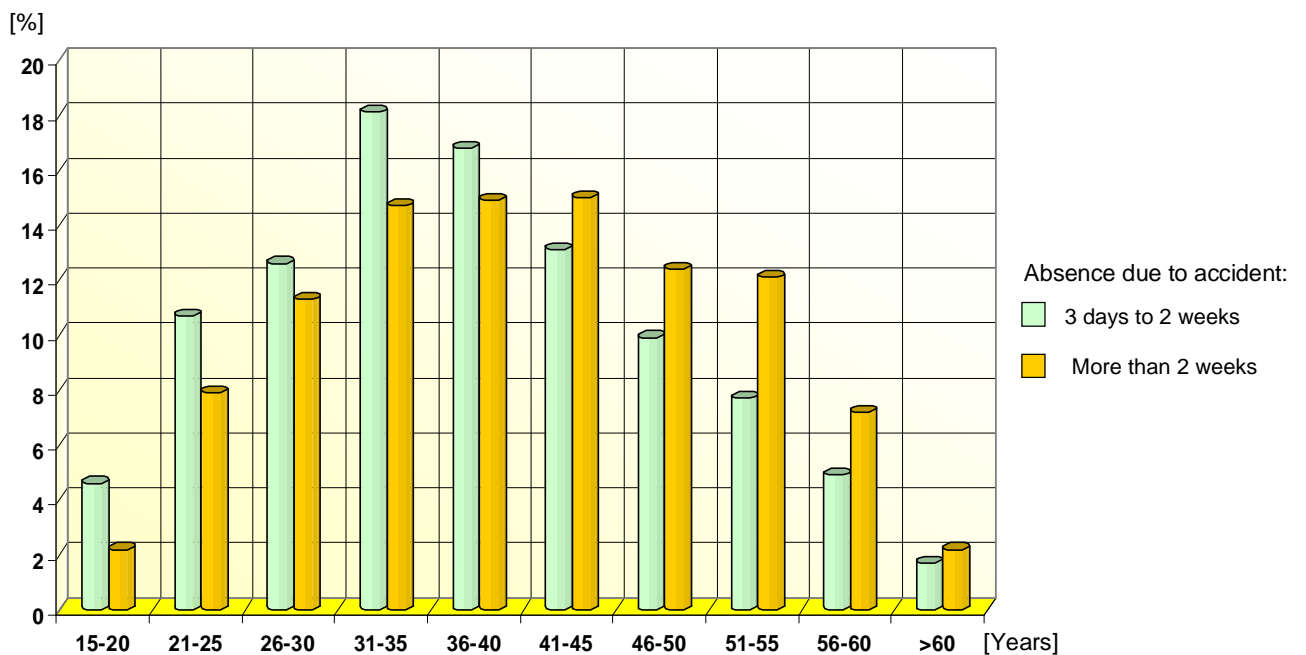
Fig. 10: Accident severity (absence due to accident)/age of injured persons

The consequences of an accident differ widely when comparing the respective age group –: whereas accidents of the age group of 31 to 40 years mostly come under the category “absent for 3 days to 2 weeks”, those over 40 years of age are much more frequently involved in accidents that cause an absence from work of more than 2 weeks.

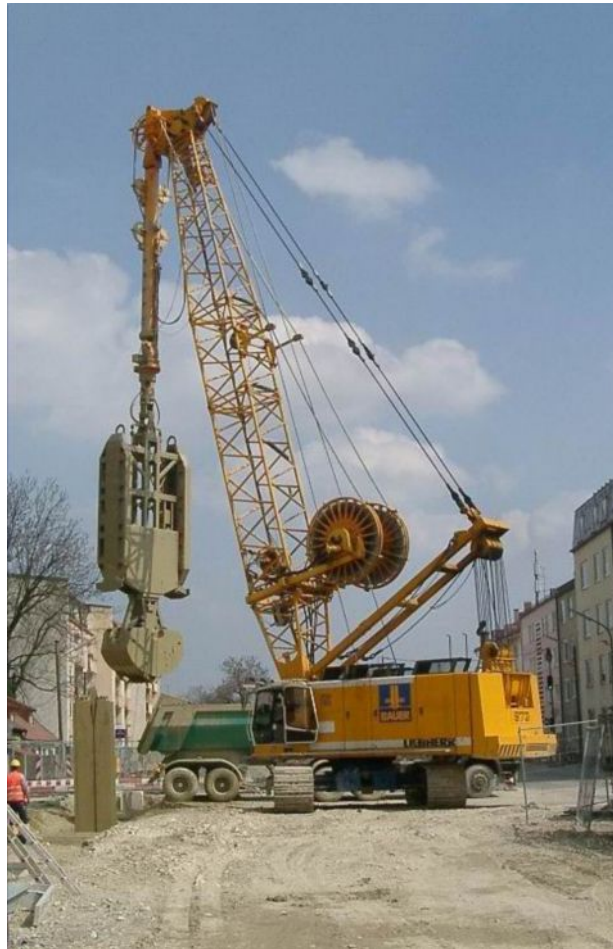
Fig. 16 Diaphragm wall preparation during the construction of the Munich subway
