Progress report

No.: 20-F-0107

Subject: R&D project „Rheology and Workability Testing of
Deep Foundation Concrete“

Client: European Federation of Foundation Contractors (EFFC)

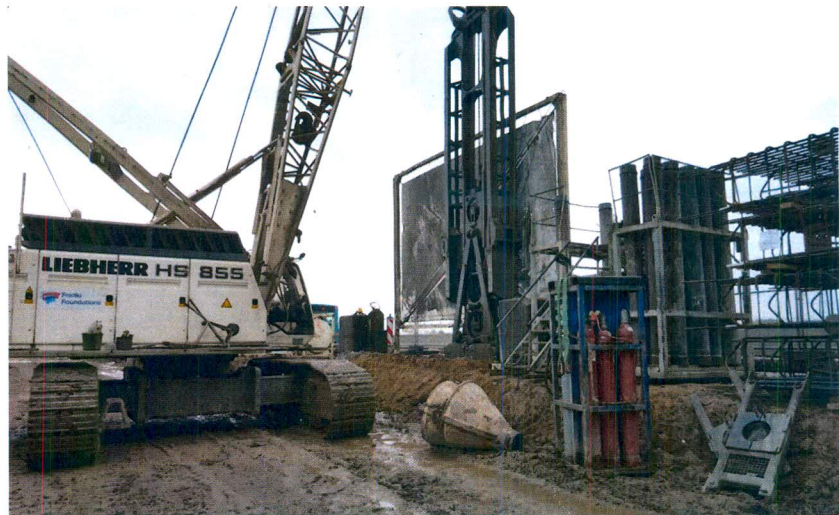
Figure 1: Excavation of a D-Wall element at Nieuw Lekkerland

The first concrete testing on construction site was carried out on October, 20th at “Nieuw Lekkerland” near Dordrecht (Netherlands). Franki Grondtechnieken B.V. (Franki) is performing maintenance work on a dike there. Two concrete types were used for this purpose, a concrete type for bored piles and a concrete type for D-Wall elements, see Figure 1. According to Franki both concretes consist of the same mix design, just the designated consistency differs from each other. The concrete for the bored piles was designed in the consistency class F4, the concrete for the D-Wall was in F5.
