SAFETY ALERT

Type of Incident: Uncontrolled shot from press nozzle.

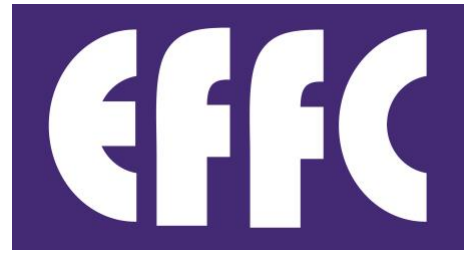
Nature of Incident/Injury: Cheek injury.

Details of Incident: During injection work with cement mix, an uncontrolled shot of the press nozzle occurred. The worker was hit in the face, causing his left cheek to be slashed. The worker was about 1 metre away from the spot. The injured man was in that place because he went there to put up the overturned warning lamp.

Action Taken, Lessons Learnt: An analysis was carried out and found: It is recommended to secure the nozzle with additional safety devices after anchoring. Additional anchorages of the nozzle. Chain to secure the hose. All work near the pressing nozzle only after the pressing process has been completed.
